**STRICTLY  
TECHNICAL**

INDEX.PAGE.

## ASSEMBLY OF INLET MANIFOLD

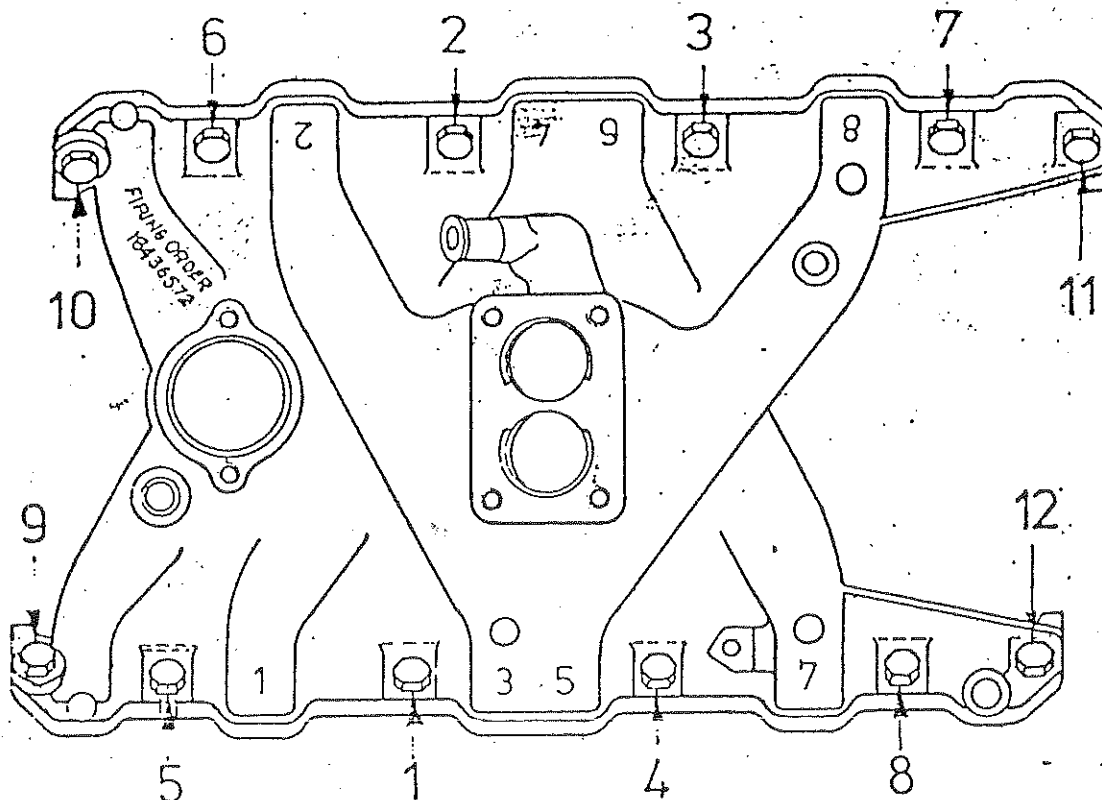
When investigating manifold gasket failure or poor idling on V8 engines it is imperative that the manifold retaining bolts be checked for length. There should be ten 1 1/2" x 3/8" and two 2" x 3/8" bolts at points 9 and 10 in Fig. 1. Instances of 1 3/4" bolts being used instead of 1 1/2" bolts have been reported. These can bottom on the threads and not fully clamp the gasket.

To minimise manifold distortion and maintain alignment between manifold and heads the following tightening procedure is required:

1. Fit valley cover gasket, align with ports then fit and tighten rubber end seals to pull valley cover gasket fully home.
2. Start all fixing screws by hand.
3. Run all screws down in sequence until contact with manifold casing is made, i.e. finger tight. If this is not done the first screw torqued will tilt the manifold in the valley and tightening the screw on the opposite bank does not correct the misalignment.
4. Tighten in sequence to 13.5 - 20 Nm (10-15 lbs. f. ft. Torque)
5. Tighten in sequence to 34 - 41 Nm (25-30 lbs. f. ft. Torque)

**NOTE:** If this is a repeat failure remove the left hand cylinder head and refit with a new gasket. Do not tighten the cylinder head until the manifold has been aligned correctly then tighten the head bolts to the correct torque.

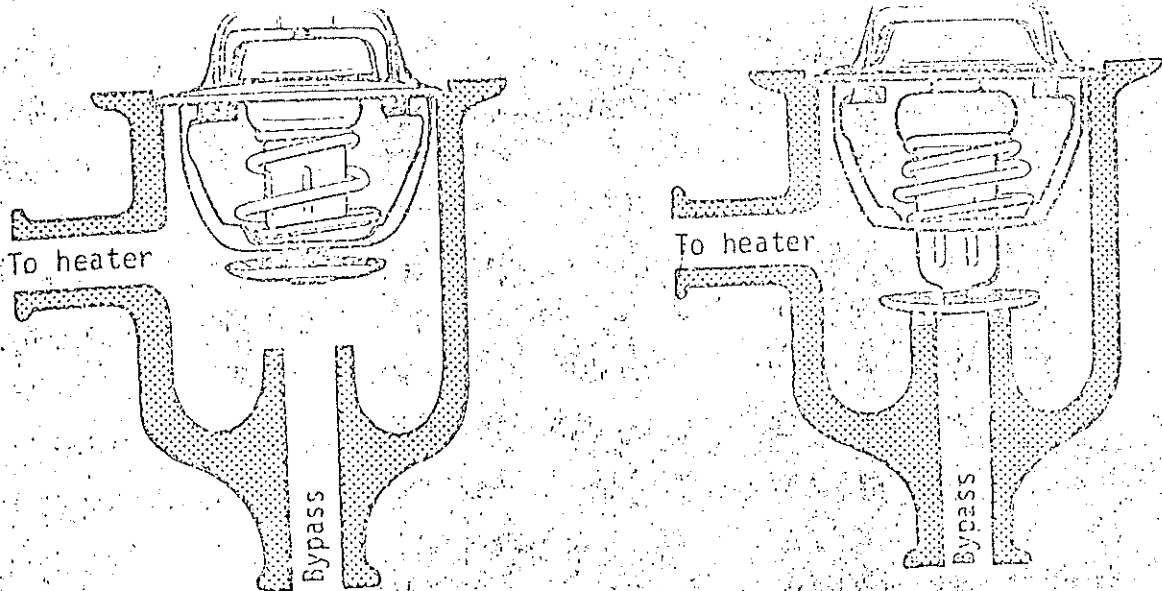
Investigations of overheating, loss of heater effectiveness and possible cylinder head gasket failure have been caused by a replacement thermostat of incorrect type being fitted. This allows the coolant to circulate through the bypass when the thermostat is open.

The correct thermostat has a spring loaded flap valve on the lower end of the wax cylinder. This valve closes the bypass when the thermostat is open ensuring correct circulation - see sketch.

Part No. 13H7508 is the only thermostat to be used on all 6 cylinder engines.

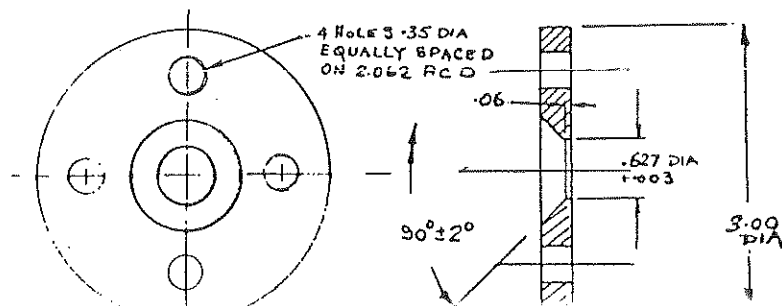
NOTE: It is essential that the new fan sit flat on the mounting face of the adaptor.

Where the machining of the adaptor is not practical, the fan mounting hole may be chamfered on the inside to clear the adaptor spigot radius, or alternatively a separate adaptor plate manufactured as shown in the attached drawing.

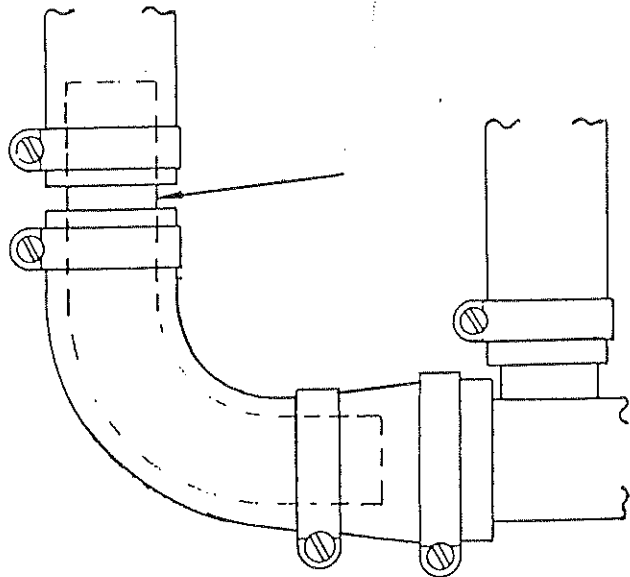
Instances of heater hoses failing adjacent to the water pump hose clip have been reported.

Should fatigue be evident, then a new hose should be fitted. In addition, further failures of this type can be prevented by the insertion of a 108 mm (4½ in) length of 12.7 mm (½ in) OD copper pipe in the hose and secured with hose clips as illustrated.

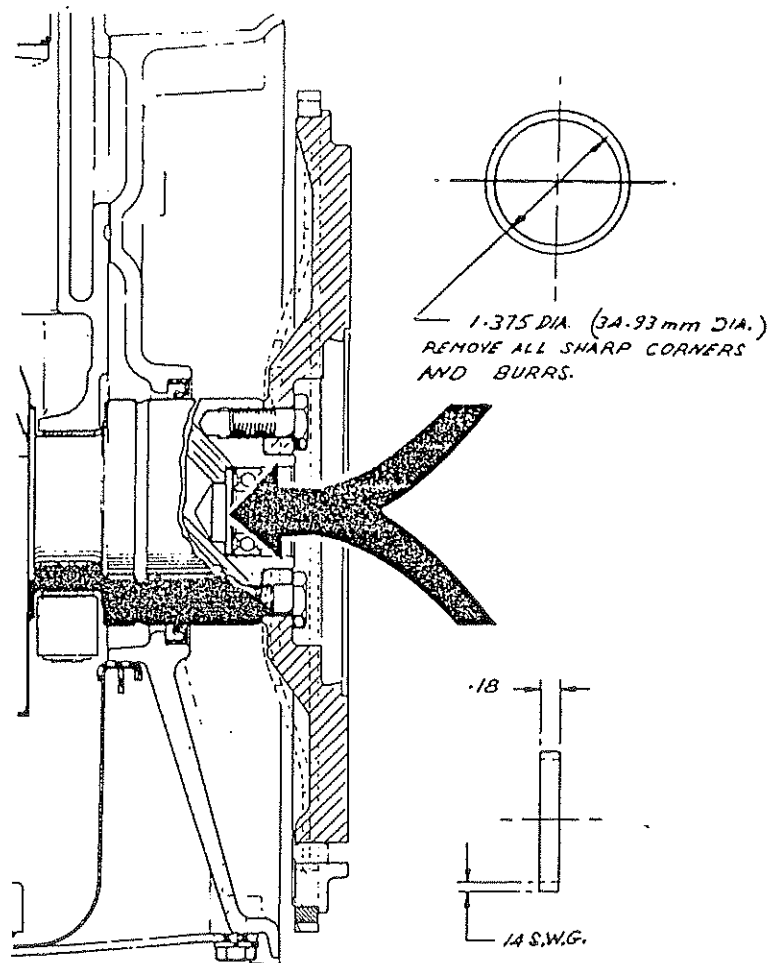
Investigation into the cause of clutch shudder in a small number of vehicles has revealed that the input shaft spigot bearing has been pressed too far into the crankshaft. The result being lack of support due to only partial engagement of the input shaft in the bearing. Later crankshafts have been designed to provide positive location of the bearing to its designed depth of 12.7 mm (0.5 in) down the bore.

Vehicles in service can be modified by the manufacture and fitment of a spacer as detailed in the following drawing.

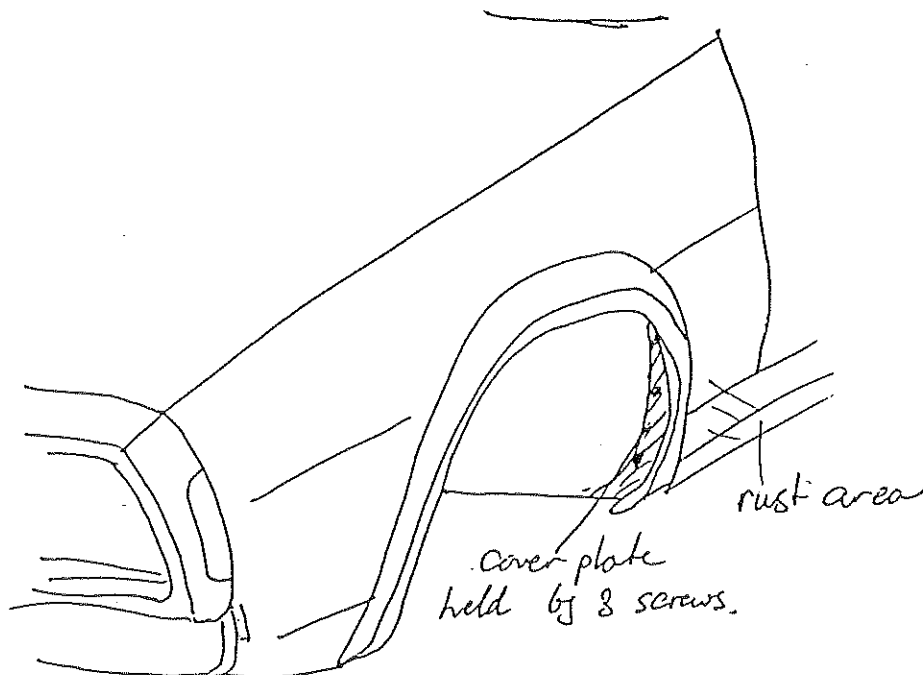
Rusting is very prevalent in the rear section of each front guard. Although there is a drain slot, mud and gravel tend to build up between the inner and outer panels. This is difficult to clear and eventually the outer panel (and no doubt the inner one as well) rust through. This area can easily be hosed clean if a small cover plate attached by three self tapping screws is removed. See diagram below.

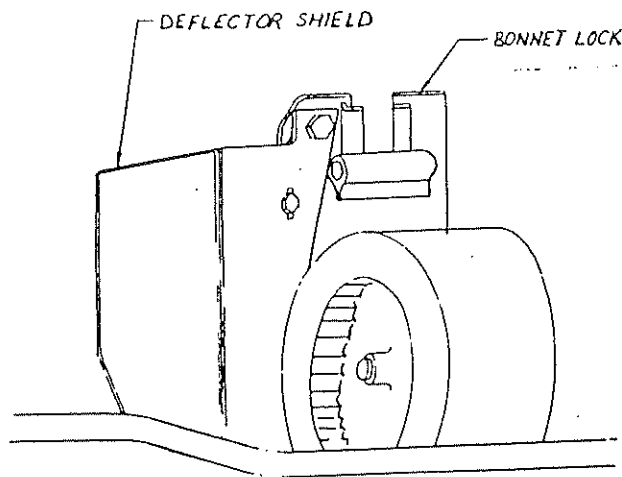
Under certain operating conditions, water from the right hand windscreen wiper blade could be deflected toward the heater fan intake, resulting in entry to the car interior.

This problem can be rectified by the manufacture and fitting of a deflector shield to the bonnet lock as shown in the following drawings.

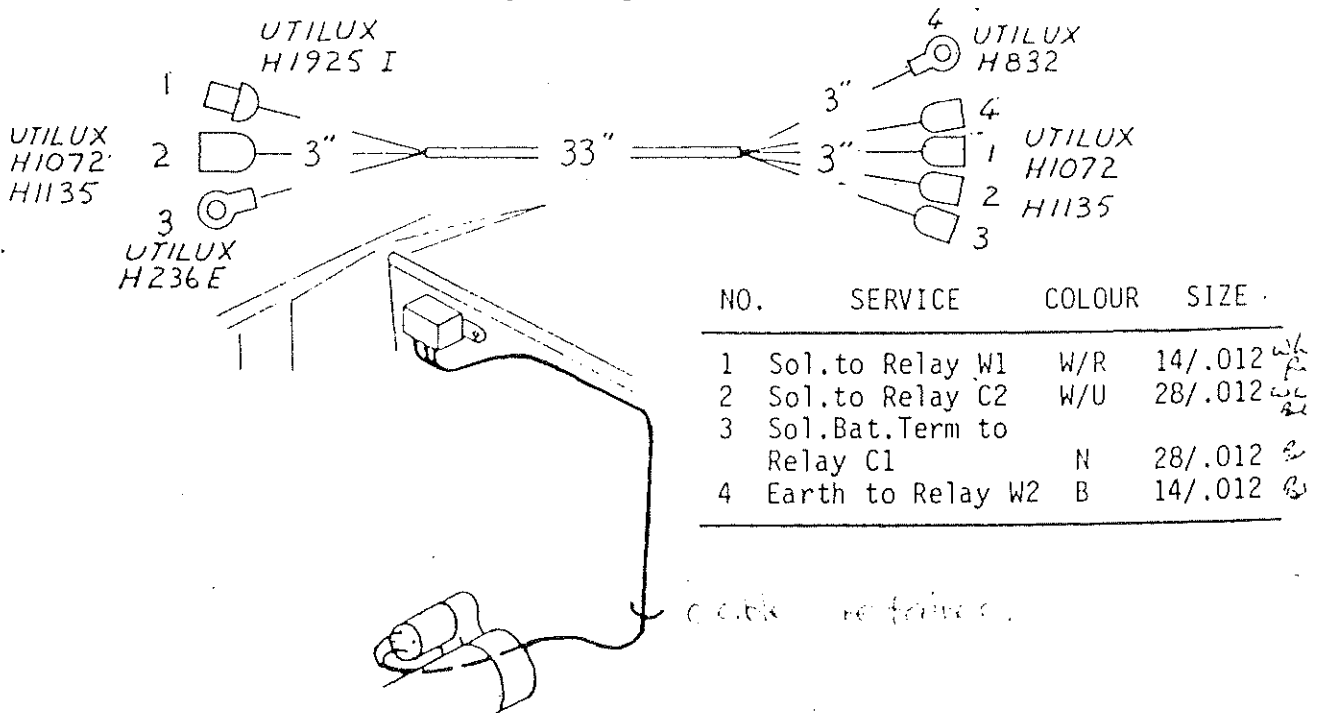
Should test indicate considerable voltage drop in the ignition switch to solenoid circuit, the following method offers an alternative solution.

1. Fit Lucas relay Part No. 33213 to the plenum chamber wall on the RH side.
2. Manufacture wiring harness as shown in drawing.
3. Route cable over brake servo and follow main harness to starter solenoid.
4. Remove white/red cable from the starter solenoid and connect to male terminal on harness.
5. Connect white/blue cable to starter solenoid terminal.
6. Connect brown cable to battery terminal on starter solenoid.
7. Connect harness to relay as shown.
8. Fit earth cable under relay fixing screw.

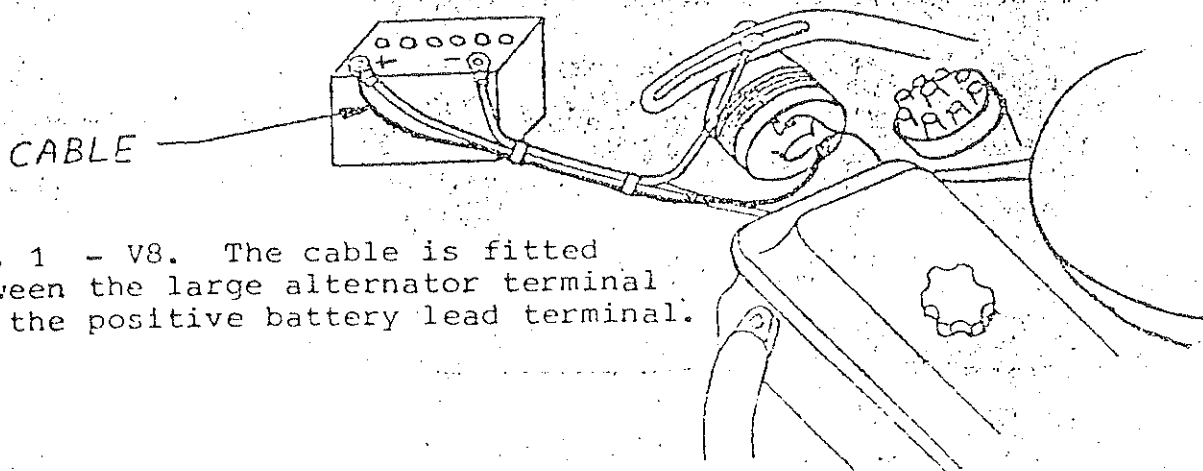
When driving at night with headlights on, the ignition warning light may glow faintly. This is due to a voltage drop between the alternator and battery. To rectify this, fit an additional cable as shown in figures one, two and three.

FIG. 1 - V8. The cable is fitted between the large alternator terminal and the positive battery lead terminal.

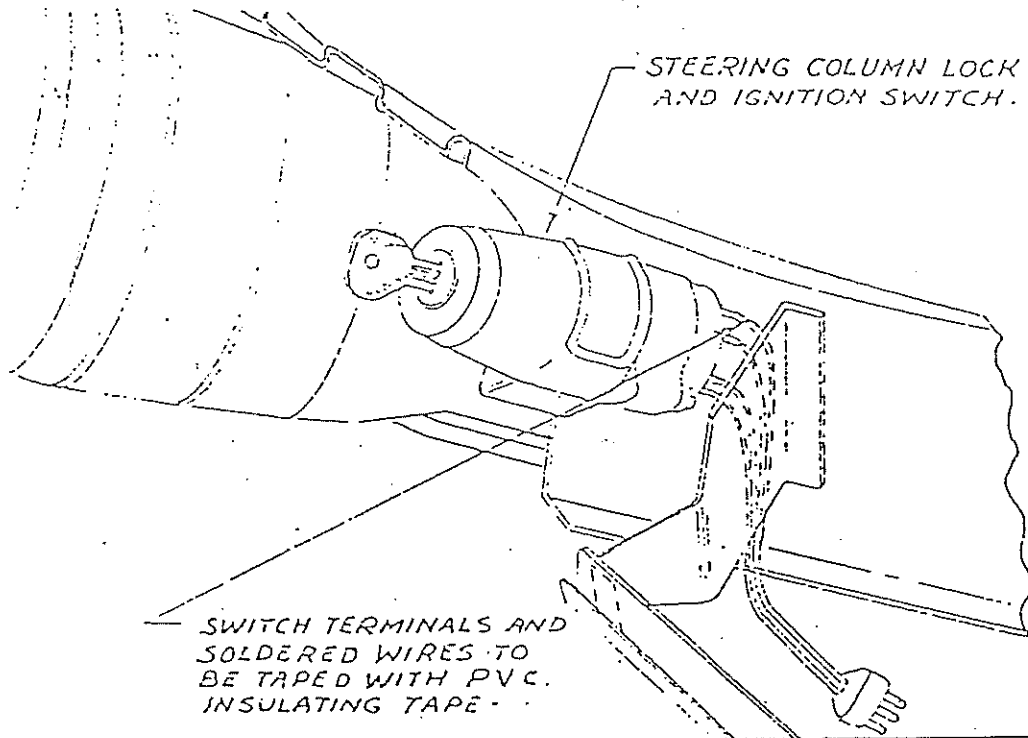
A condition can exist on early production vehicles where there is inadequate clearance between the fascia bracket and the wiring at the base of the lock. See Fig.2. All early production vehicles should be inspected to see that adequate clearance exists in this area. If the clearance is inadequate, the fascia bracket should be bent, or, alternatively, the wiring loom and switch terminals should be taped to prevent chafing and consequent short circuit or fire hazard.

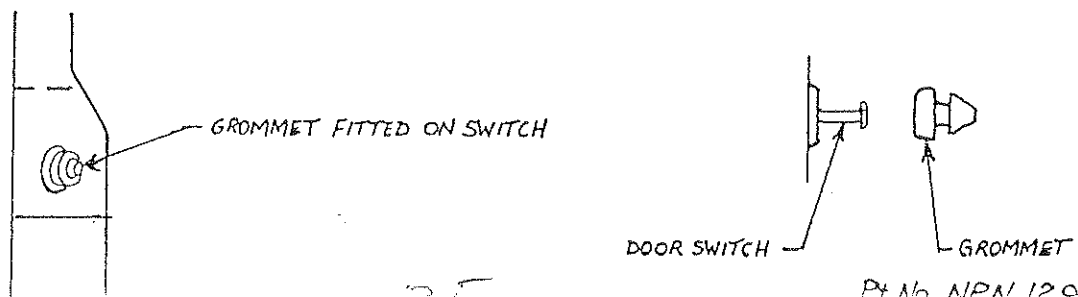
A similar problem to the above can occur with the courtesy lamp switches in the doors. Insufficient travel of the plunger allowing interior lamps to flicker or stay on. This can be rectified by the addition of a medium sized body grommet fitted to the switch as illustrated.

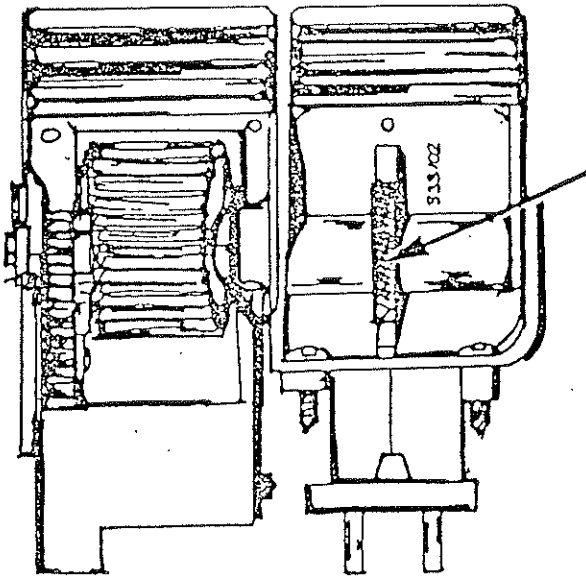
It has been found that over-travel of the switch when in the headlight position is a major cause of the headlights flickering or going out.

This can be rectified by interposing sufficient cork gasket material between the switch stop and bracket to eliminate the free play. Refer sketch. The gasket material should be secured with 3M .1099 or pliabond. Additionally it is important to ensure that the moulded plug is secure on the pins at the rear of the switch and that the main and dip beam fuses are tight in the holder.
