**STRICTLY  
TECHNICAL**

INDEX.PAGE.

## ASSEMBLY OF INLET MANIFOLD

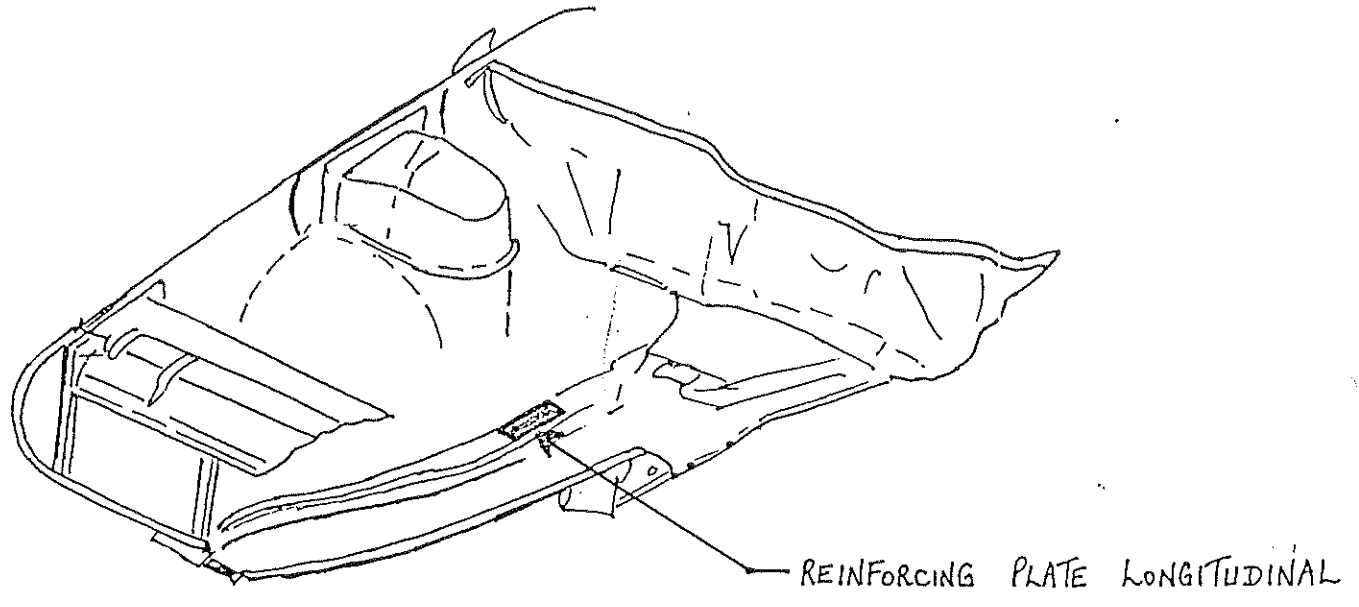
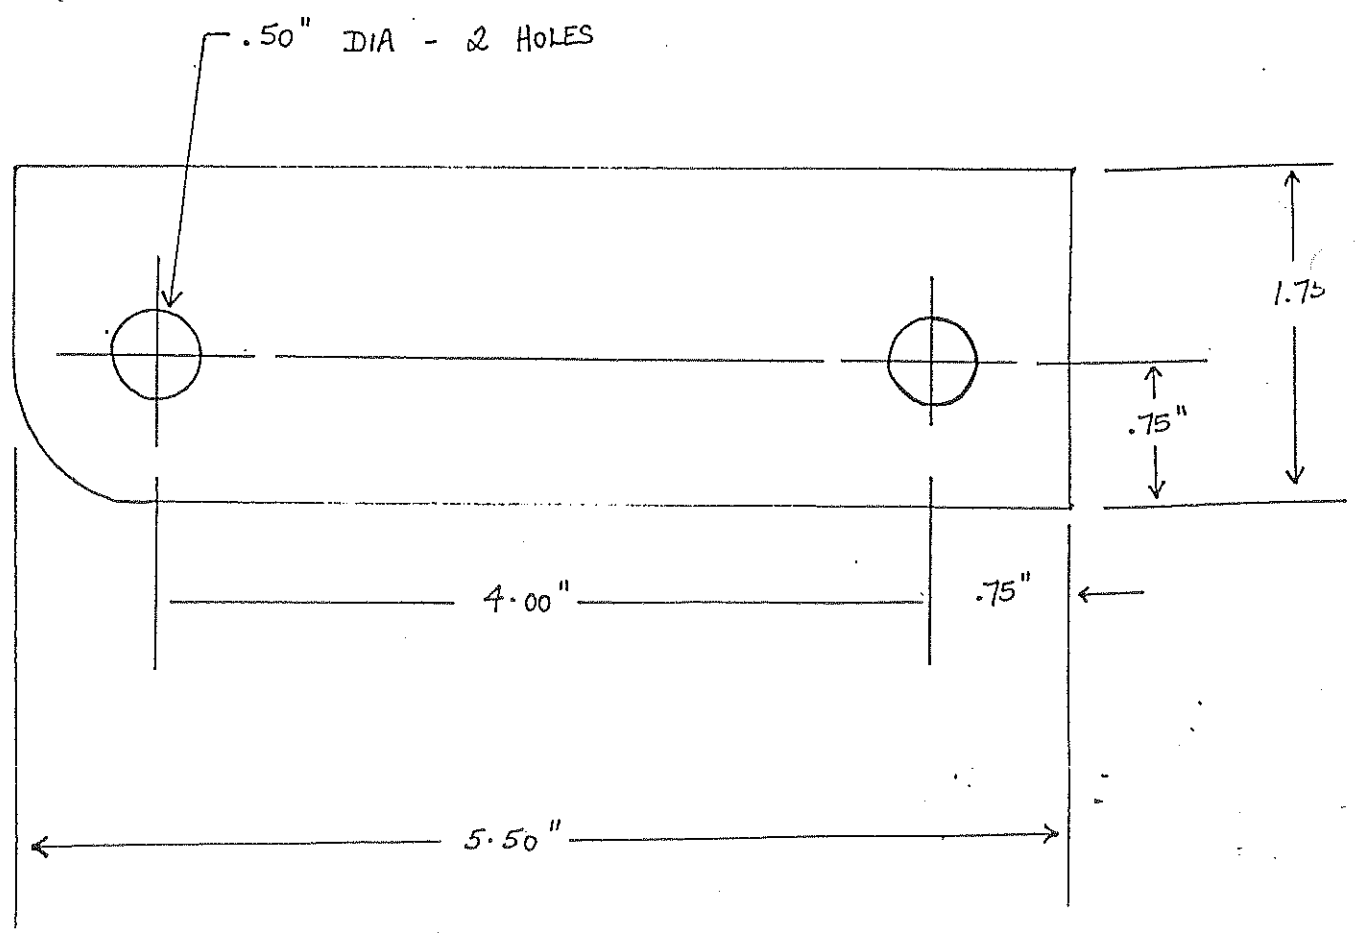
Vehicles prior to the introduction of this modification may suffer from a rattle in this area due to movement of the crossmember. It is recommended that a 1/8" thick reinforcement plate is substituted for the flat washers used under the mounting bolt lock nuts.

To add the reinforcing plate remove the rear 7/16" UNF cone type locknut (MYH0790) and the plain washer (PWZ0107). Make sure that the bolt (HBZ0732) does not fall through. Place the reinforcing plate (HYC7834) with the rounded corner over the bolt and replace the locknut. Finger tighten the locknut. Do not replace the washer.

Undo the front locknut and remove the plain washer. Slide the reinforcing plate over the bolt and replace the locknut. Retighten the rear locknut.

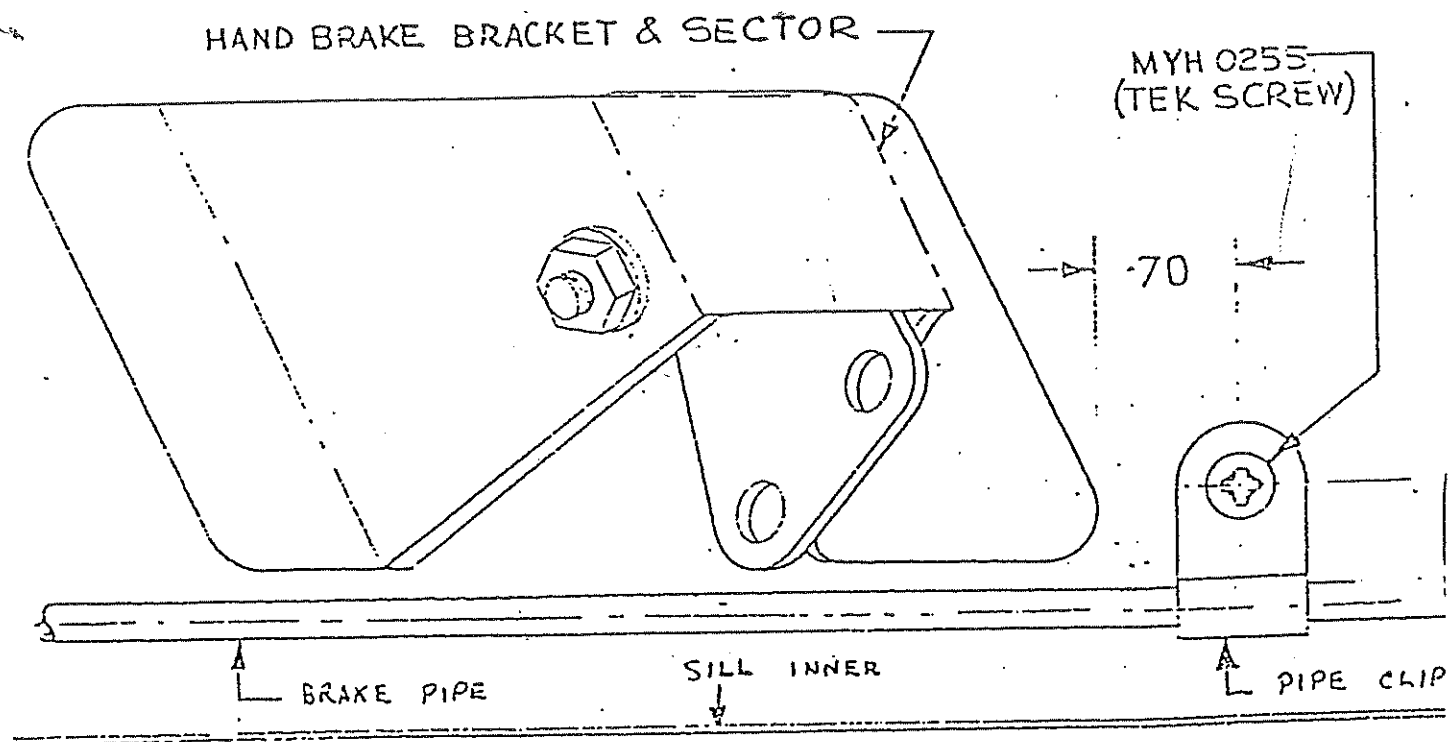
A number of early production vehicles have been built with a weld tag approximately 3" behind the right hand side body sill mounting bracket for the hand brake sector. This weld tag was intended to hold the brake pipe into the sill so that the pipe would clear the sector travel path.

The pipe should run below the tag and have the tag bent down over it. Some vehicles have had the pipe placed above the tag which could result in a chafe condition between the pipe and the sector. Later production vehicles have a 'P' clip fitted. See Fig. 1. All vehicles should be checked and, if this problem exists, should be corrected.

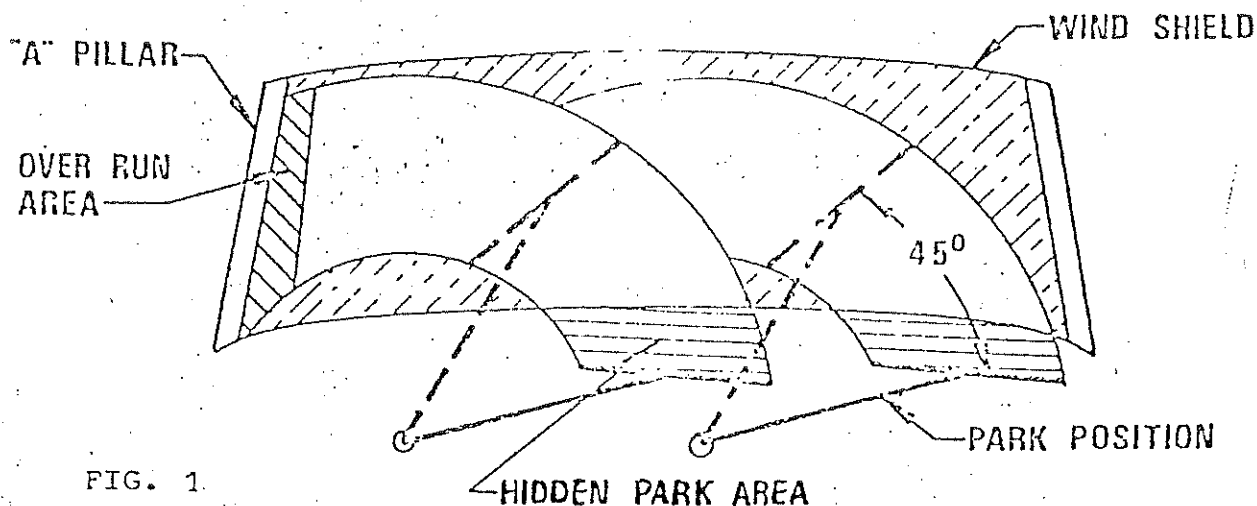
FIG. 1

Operate the system and move the wiper switch to OFF as the blades commence the down stroke. A reverse action of wipe should take place. If the arc of wipe increases on this reverse stroke causing the drivers side blade to hit the 'A' Pillar or move past the Pillar, it may be assumed that the cam locking Plate (FIG 2) is 'out of square' not operating correctly. The following procedure should be followed:

5) Turn off the ignition switch when the Pivot rotation is at the extent of its travel toward the 'A' Pillar (see FIG. 1)

6) Position the drivers side arm and blade leaving clearance on the 'A' Pillar similar to that shown in FIG 1.

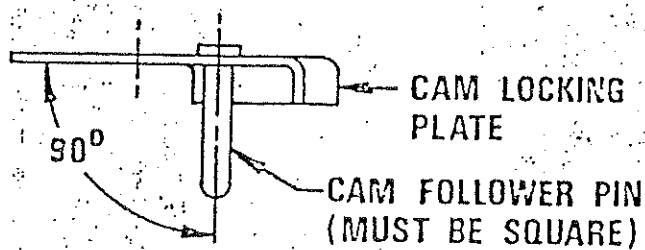
FIG. 2

2) Move the arms manually from the Parked Position at the stops to a Position approximately 45 degrees UP the screen shown in FIG 1. The cam follower locking Plate should now engage with the opening in the motor crank and lock the arms. If this does not occur, it is Probable that the cam follower Pin is 'out of square' (refer FIG 2) and is unable to engage the spring- FIG 3.
